THE NEW ZEALAND SOCIETY ON LARGE DAMS

GUIDELINES ON INSPECTING SMALL DAMS

November 1997

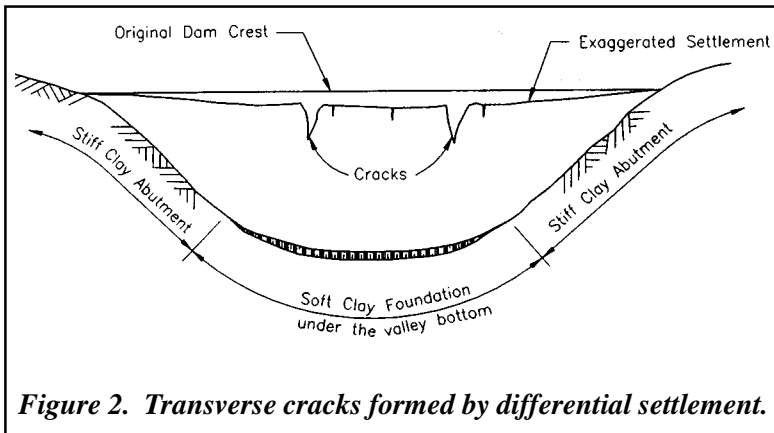
Figure 2. Transverse cracks formed by differential settlement.

Transverse cracks, running upstream/downstream, are usually formed as a result of differential settlement (refer Figure 2). Deep cracks may collect rainfall and lead to erosion. Those cracks which extend from the reservoir to the downstream face usually lead to an erosion failure of the dam. Professional advice should be sought to assess the significance of any cracks increasing in size or depth.
